Paper No. 15-1097

***Quantitative Method for Assessing Deterioration Level
of Wood Guardrail Posts***

Chuck Plaxico
RoadSafe, LLC

Paper prepared for consideration for presentation and publication at the
94th Annual Meeting of the Transportation Research Board, January 2015

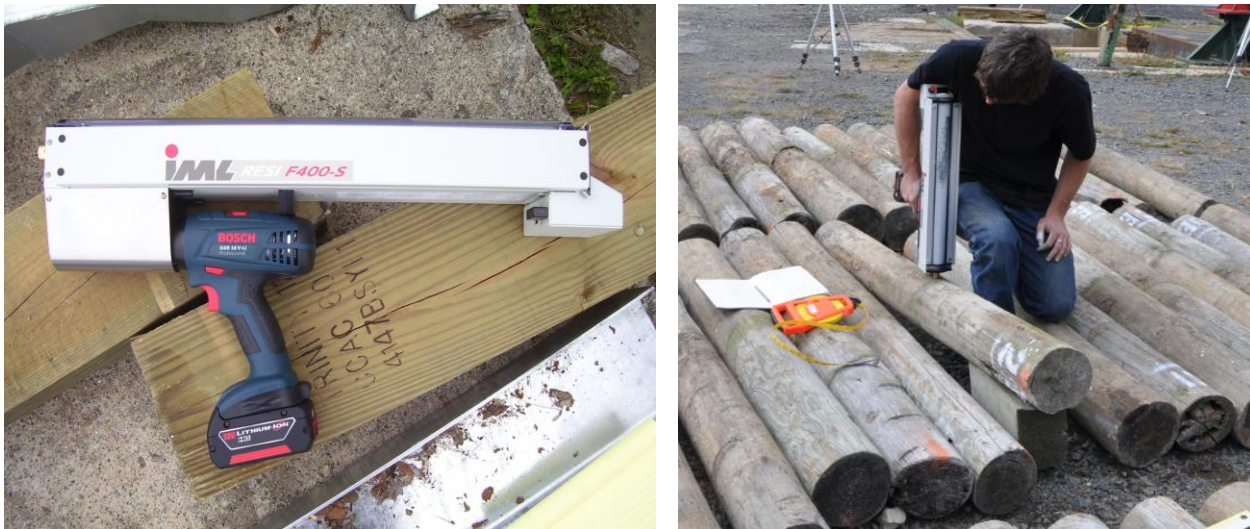
10 RESISTOGRAPH MEASUREMENTS

18
19 **Figure 1. IML Resi-F400 S Resistograph**

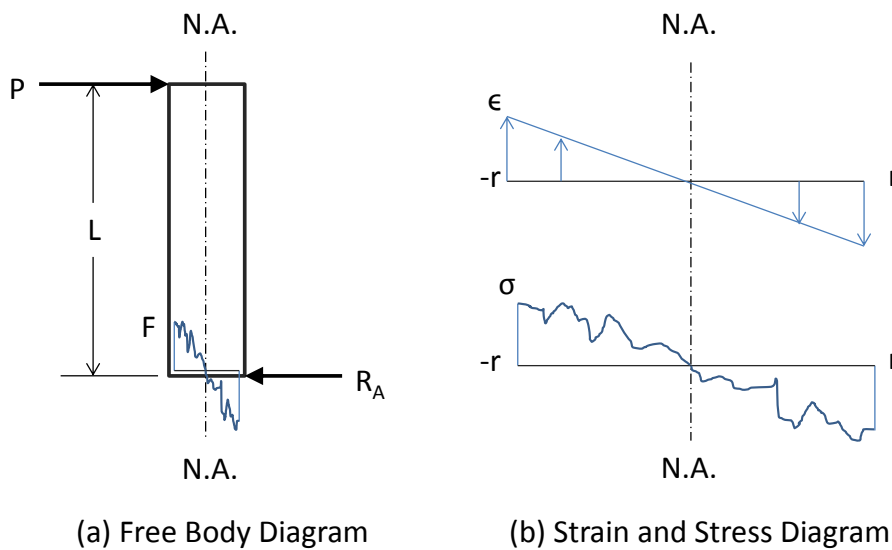
3 Where M is the bending moment, I is the moment of inertia of the beam, and c is the
 4 distance from the neutral axis of the beam. Since M and I are constants, the strain varies linearly
 5 through the cross-section, increasing from zero at the neutral axis to a maximum value at the
 6 outermost fiber of the beam. If the material is elastic and homogeneous then the stress also varies
 7 linearly through the cross-section. For a non-homogeneous material such as wood, on the other
 8 hand, the stress values vary through the cross-section as a function of the local wood modulus, as
 9 illustrated in the schematic in Figure 2.

11 **Figure 2. Schematic of typical (a) Free-body and (b) strain and stress diagrams for non-**
 12 **homogeneous beam under bending load (positive in compression).**

13 From the free body diagram in Figure 2, equilibrium is achieved when the sum of the
 14 moments due to the internal forces at Point A are equal to the moment created by the applied
 15 force P times its distance L , as described by:

16 If the internal force at Point A in Figure 2 is approximated in terms of discrete forces, F_i ,
 17 acting at fixed increments, y_i , through the cross-section of the post, as illustrated in Figure 3, then
 18 the equilibrium condition can be re-written as:

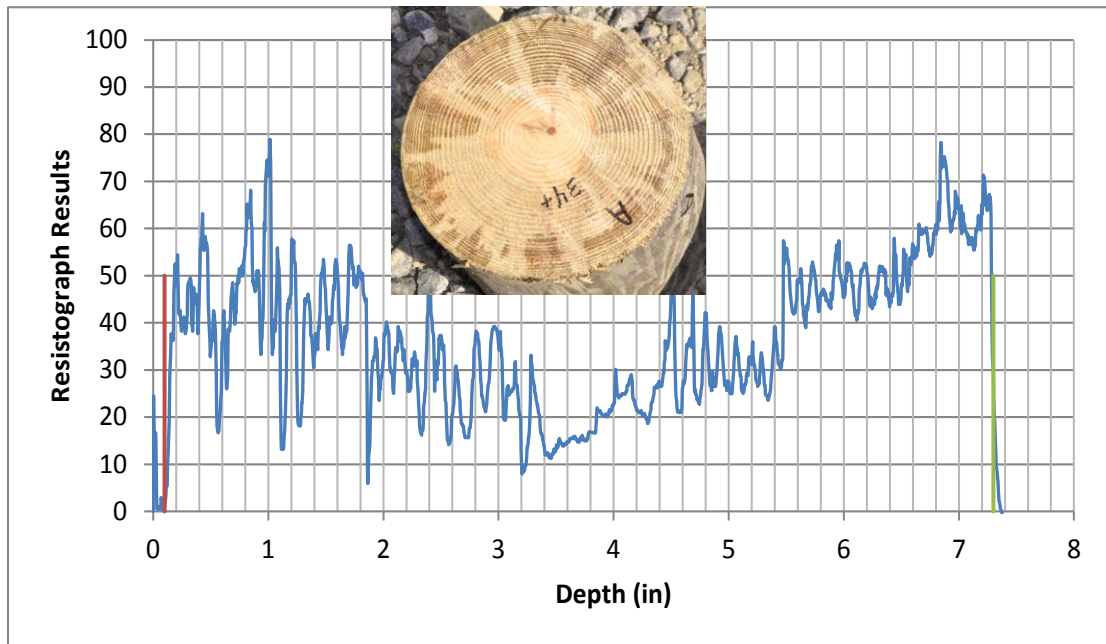
Figure 4 shows the resistograph results for one of the new posts (i.e., Post A), illustrating a typical torque vs. depth plot through the cross section of a guardrail post. It is assumed that the torque resistance amplitude at each point is directly proportional to the modulus (or strength) of the post fibers at that location. Thus, for a given applied load, each data point from the resistograph can be converted to a “pseudo” force value using the following equation:

Figure 4. Resistograph results for Post A.

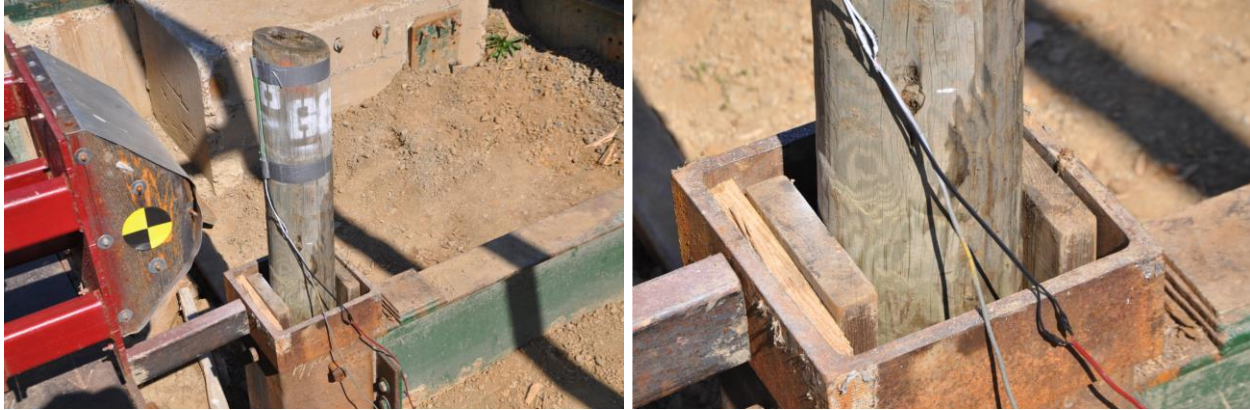
4 The tests were performed with the posts installed in a rigid steel sleeve, as shown in Figure 5.

5 The sleeve was a 12 x 12 x ¼ inch steel tube fabricated from A500 Class B 58,000 psi structural
6 steel. The top of the tube was reinforced with a 5-inch tall 13 x 13 x ½ inch steel tube welded to
7 the main tube sleeve. The foundation sleeve was braced against the steel reinforced concrete wall
8 on the inside of the ground-pit using a 7.4 ft long S20x86 structural steel section. The posts were
9 mounted inside the sleeve at a nominal depth of 38 inches, except for the few cases in which the
10 length of the post was too short (e.g., several of the posts were only 60 inches long, which
11 resulted in an embedment of 32 inches). In all cases, the top mounting height of the posts was
12 nominally 28 inches. The posts were held in place inside the sleeve using structural grade pine
13 boards (e.g., 2x8) that were press-fit against the back-side of the sleeve using a 1.0-inch diameter
14 grade 8 set-screw.

1
2 **Figure 5. Rigid steel sleeve used for post mounting.**

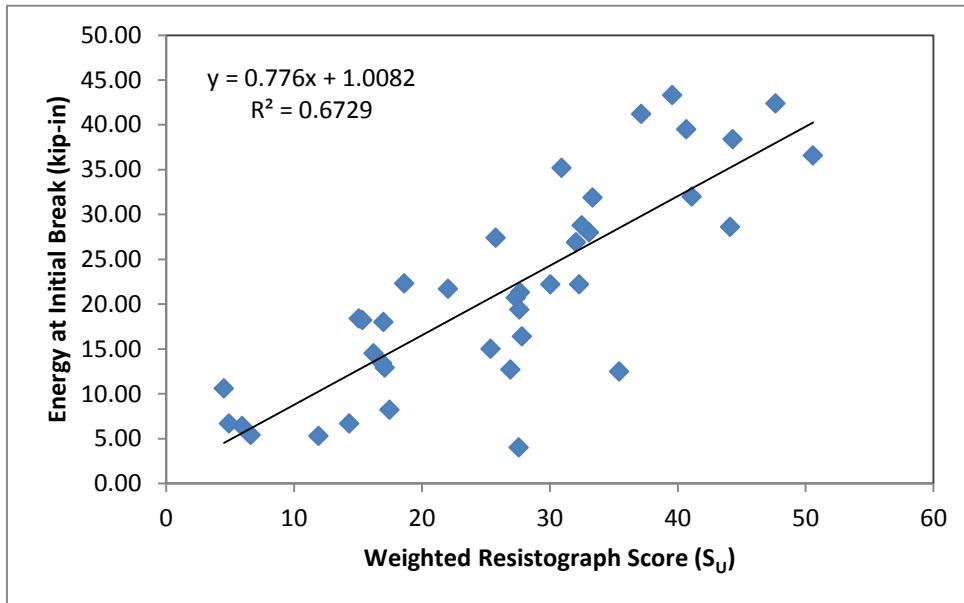
22 Figure 6 shows a plot of the peak impact force vs. S_{MOR} ; Figure 7 shows a plot of the
23 strain at initiation of rupture vs. S_{U*} ; and Figure 8 shows a plot of the rupture energy vs. S_{U*} .
24 The linear regression of the data for the peak force and peak moment curves yielded R^2 values of
25 0.69 and 0.68, respectively, which indicated that both curves fit the data reasonably well. The
26 linear regression fit of the energy at rupture initiation yielded an R^2 value of 0.67, which
27 indicated that this curve was also a reasonable fit. The linear regression for the rupture energy
28 data yielded R^2 value of 0.46 which indicated a significant scatter in the data. From visual
29 inspection, however, it seems apparent that the rupture energy does indeed increase somewhat
30 linearly with respect to S_U , with the exception of three data points, which correspond to tests

Figure 7. Energy at rupture initiation vs. S_U .

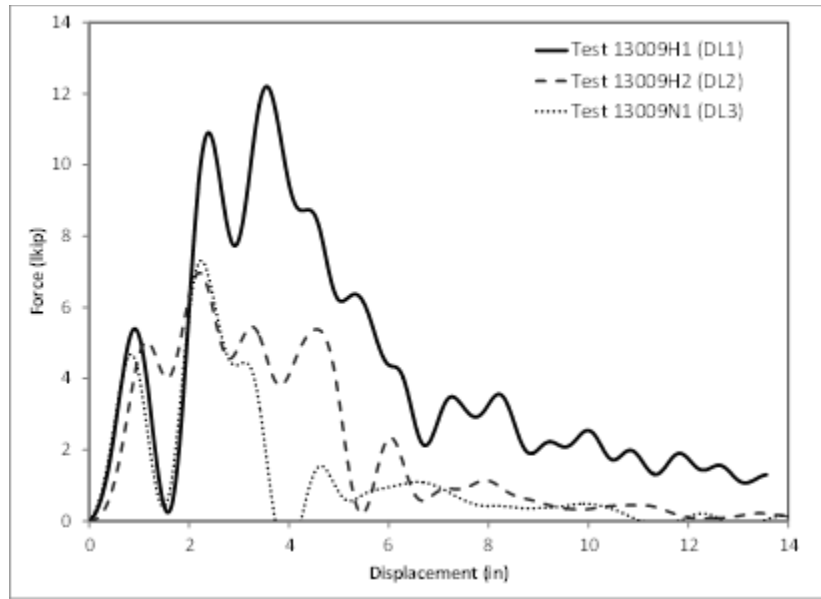
Figure 9. Pendulum test results corresponding to deterioration damage level.

22 Four levels of deterioration for wood guardrail posts were established based on the results of the
 23 pendulum impact and are defined in Table 4 in terms of force capacity, energy capacity and the
 24 weighted resistograph scores, S_u and S_{MOR}. Figures 9 shows the results from three tests
 25 performed in the 13009 test series that are representative of the three deterioration levels DL1,
 26 DL2 and DL3. Figure 10 shows a graphical representation of the damage levels with respect to
 27 resi-score, S_U, and strain energy capacity; Figure 11 shows a graphical representation of damage
 28 levels with respect to resi-score, S_{MOR}, and load capacity. The two resi-scores, S_U and S_{MOR}, are
 29 computed slightly differently, but the resulting scores corresponding to damage levels are very
 30 similar; thus, either may be used. The last column of Table 4 presents the damage levels of the
 31 post in terms of relative capacity. Therefore, if post strength is measured or otherwise determined

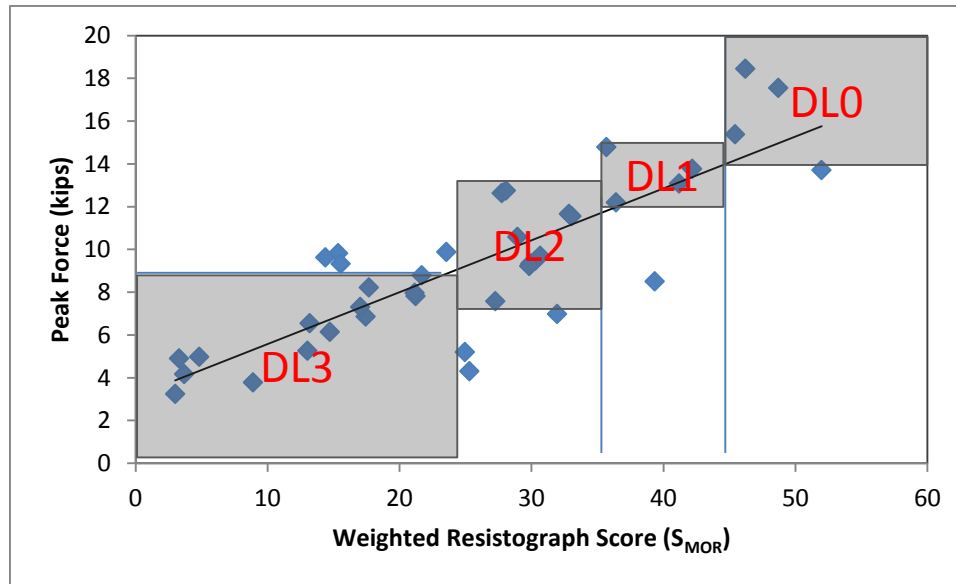
43 **Figure 11. Graphical representation of damage levels with respect to resi-score, S_{MOR} , and**
 44 **load capacity.**
