APPENDICES

Drawings for the Concrete Reaction Tension System (CRTS)
Quickchange Movable Barrier (QMB)

Drawings for the 18-Inch Tall Variable Length Barrier

Sequential Views for Case 1 from FEA for Leading-End Impact Cases on the CRTS Barrier

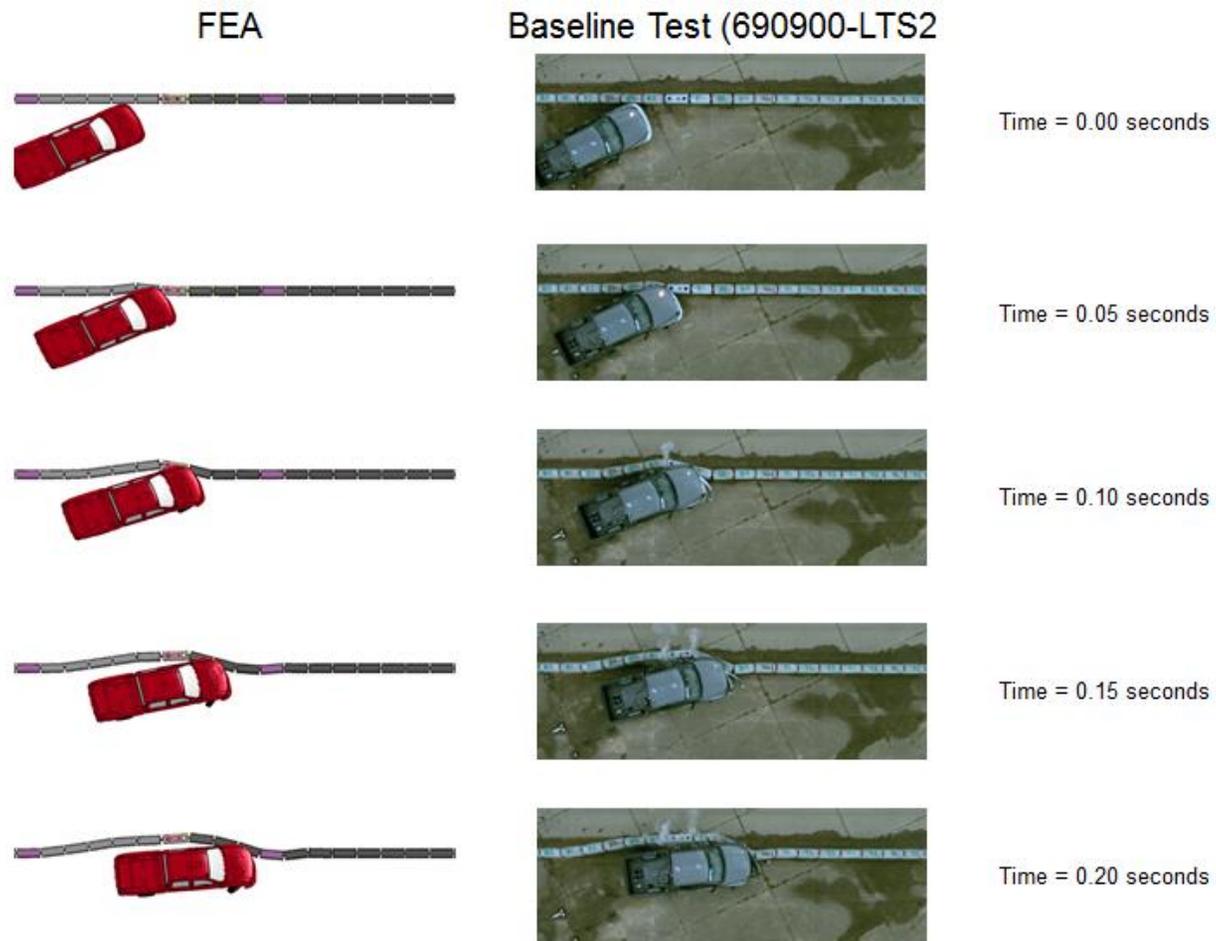
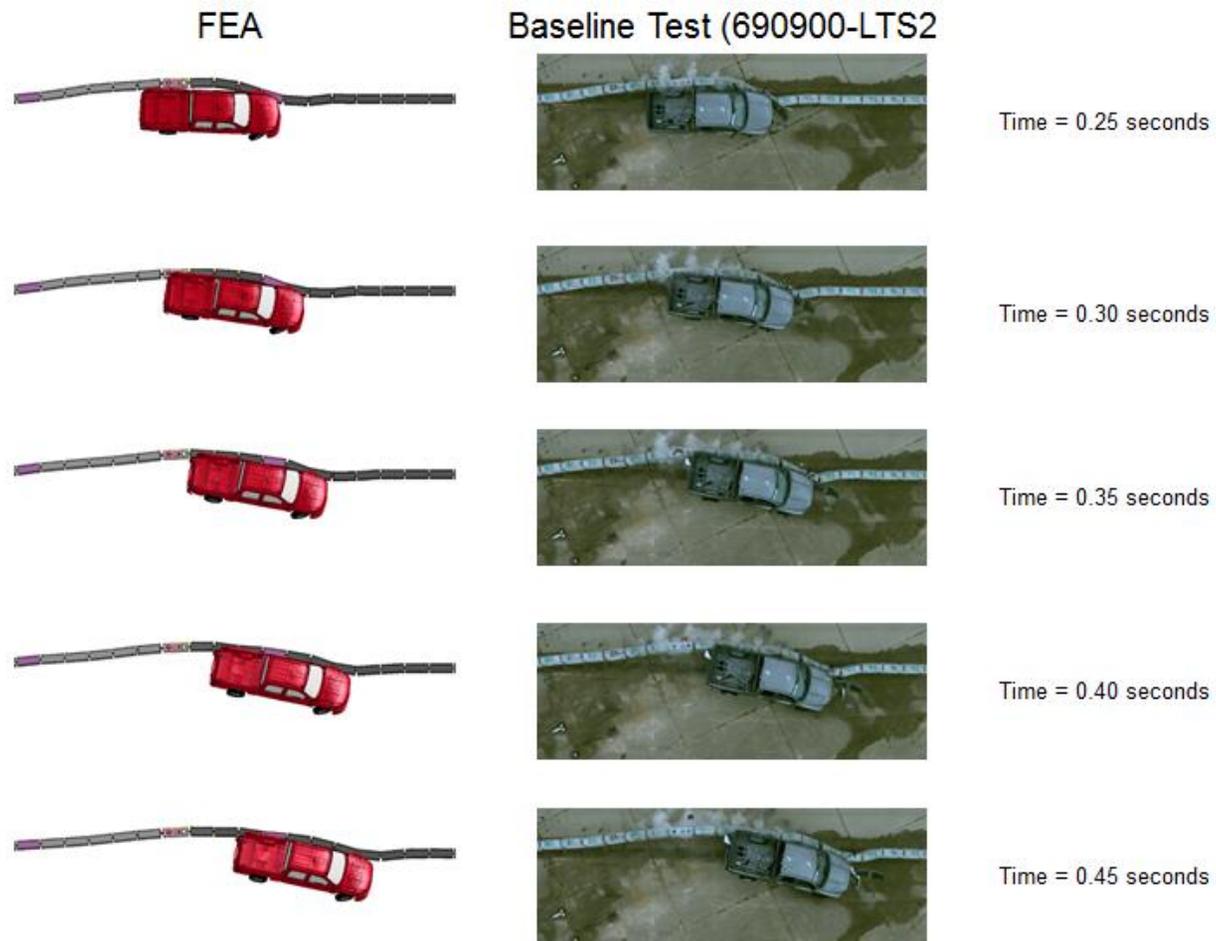
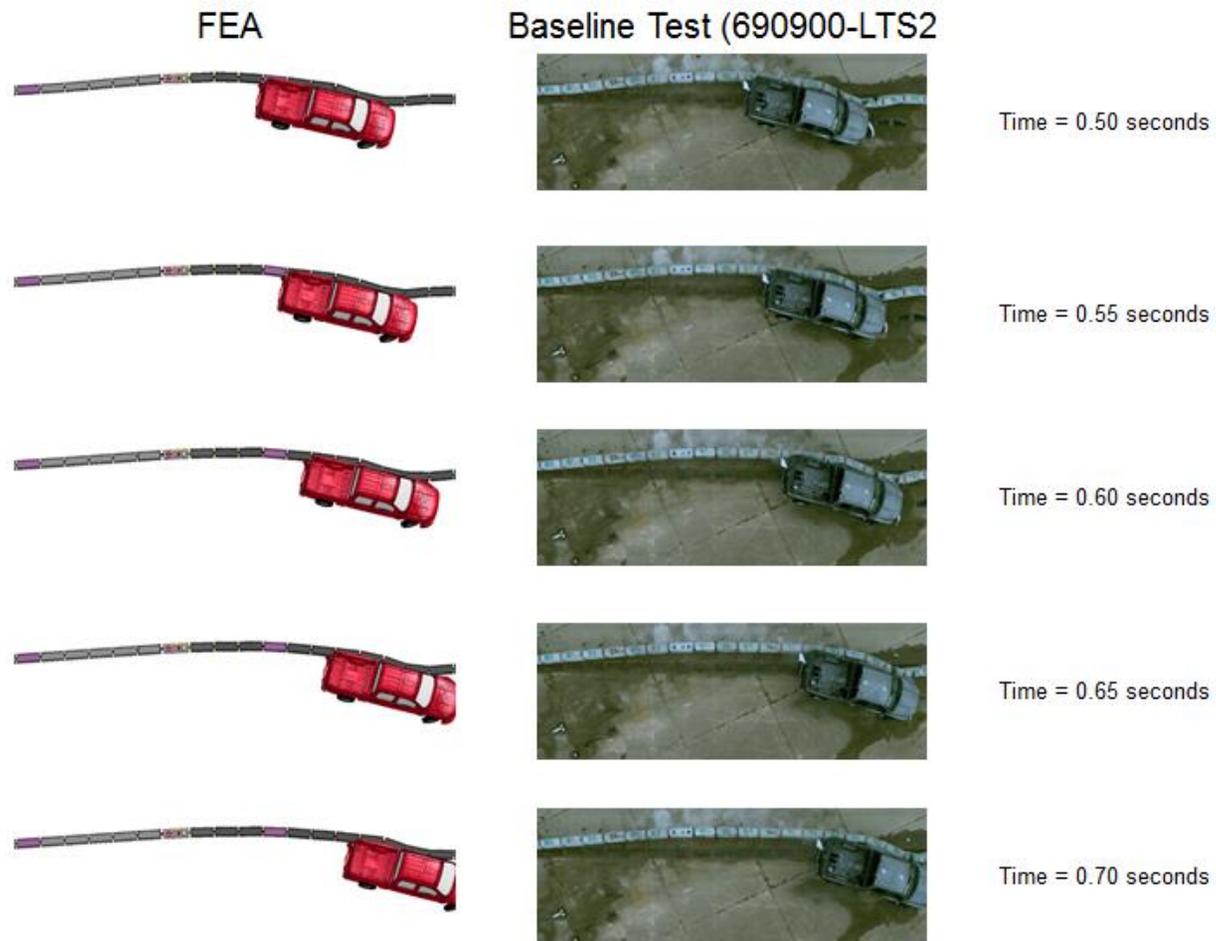
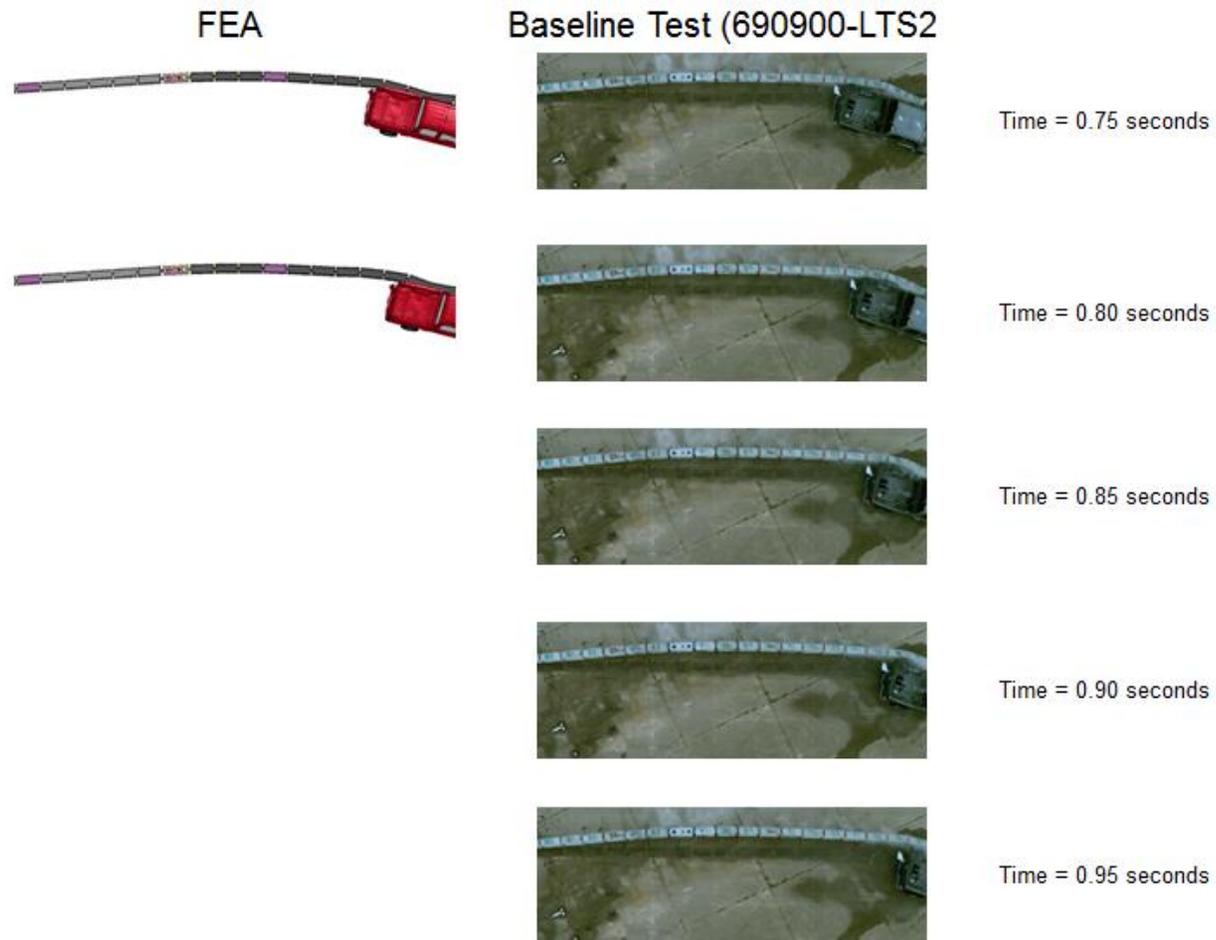
Figure 6. Sequential views for FEA and Test 690900-LTS2 under MASH Test 3-11 impact conditions from an overhead viewpoint.

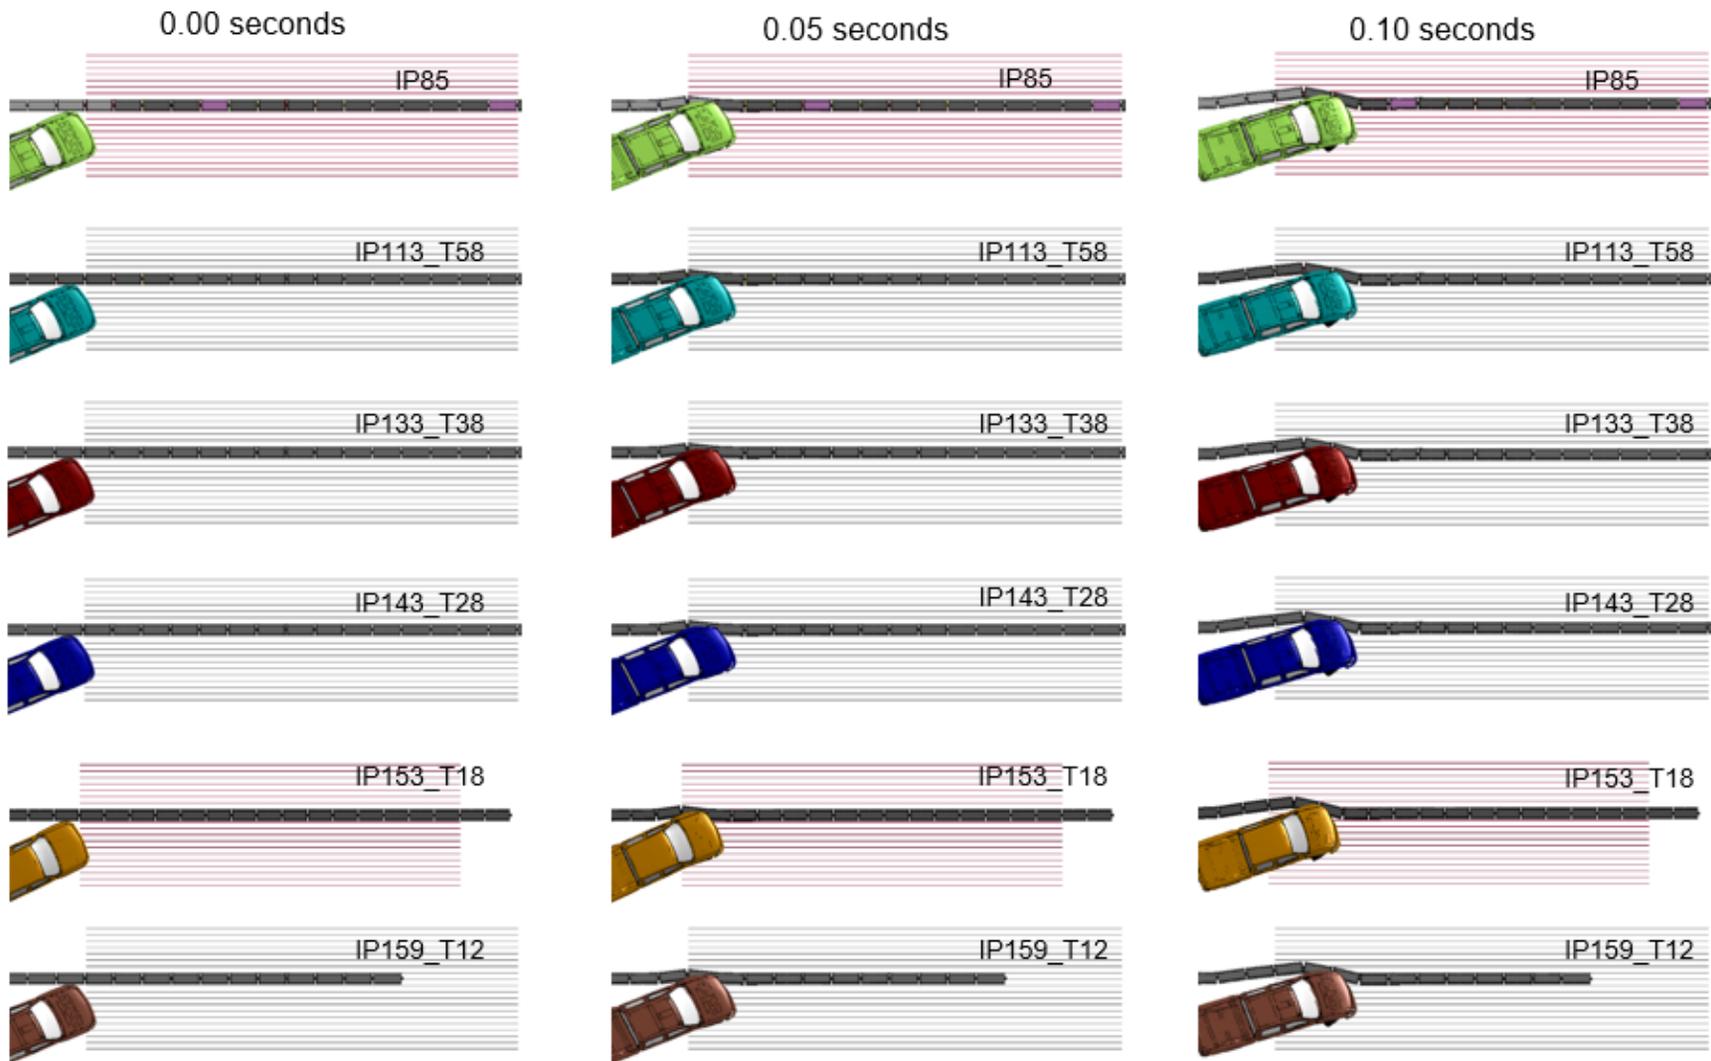
Figure E-1. Sequential views from an overhead viewpoint for IP85 through IP159_T12.

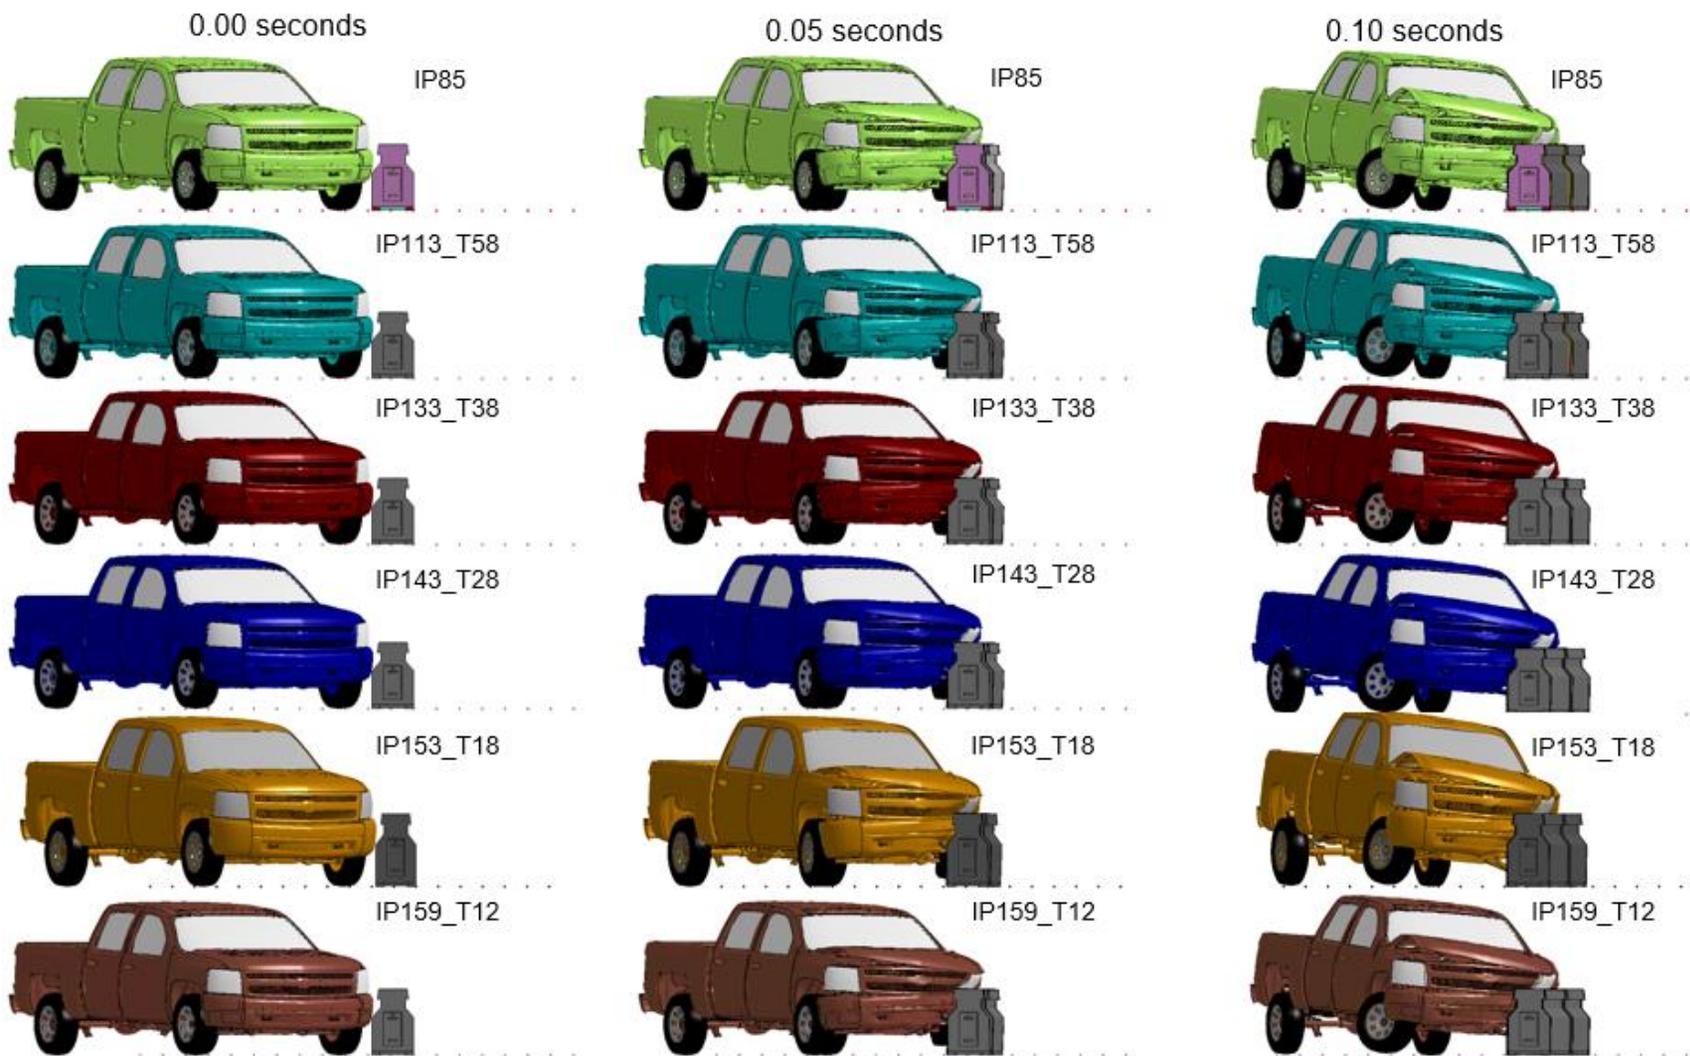
Figure E-2. Sequential views from a downstream viewpoint for IP85 through IP159_T12.

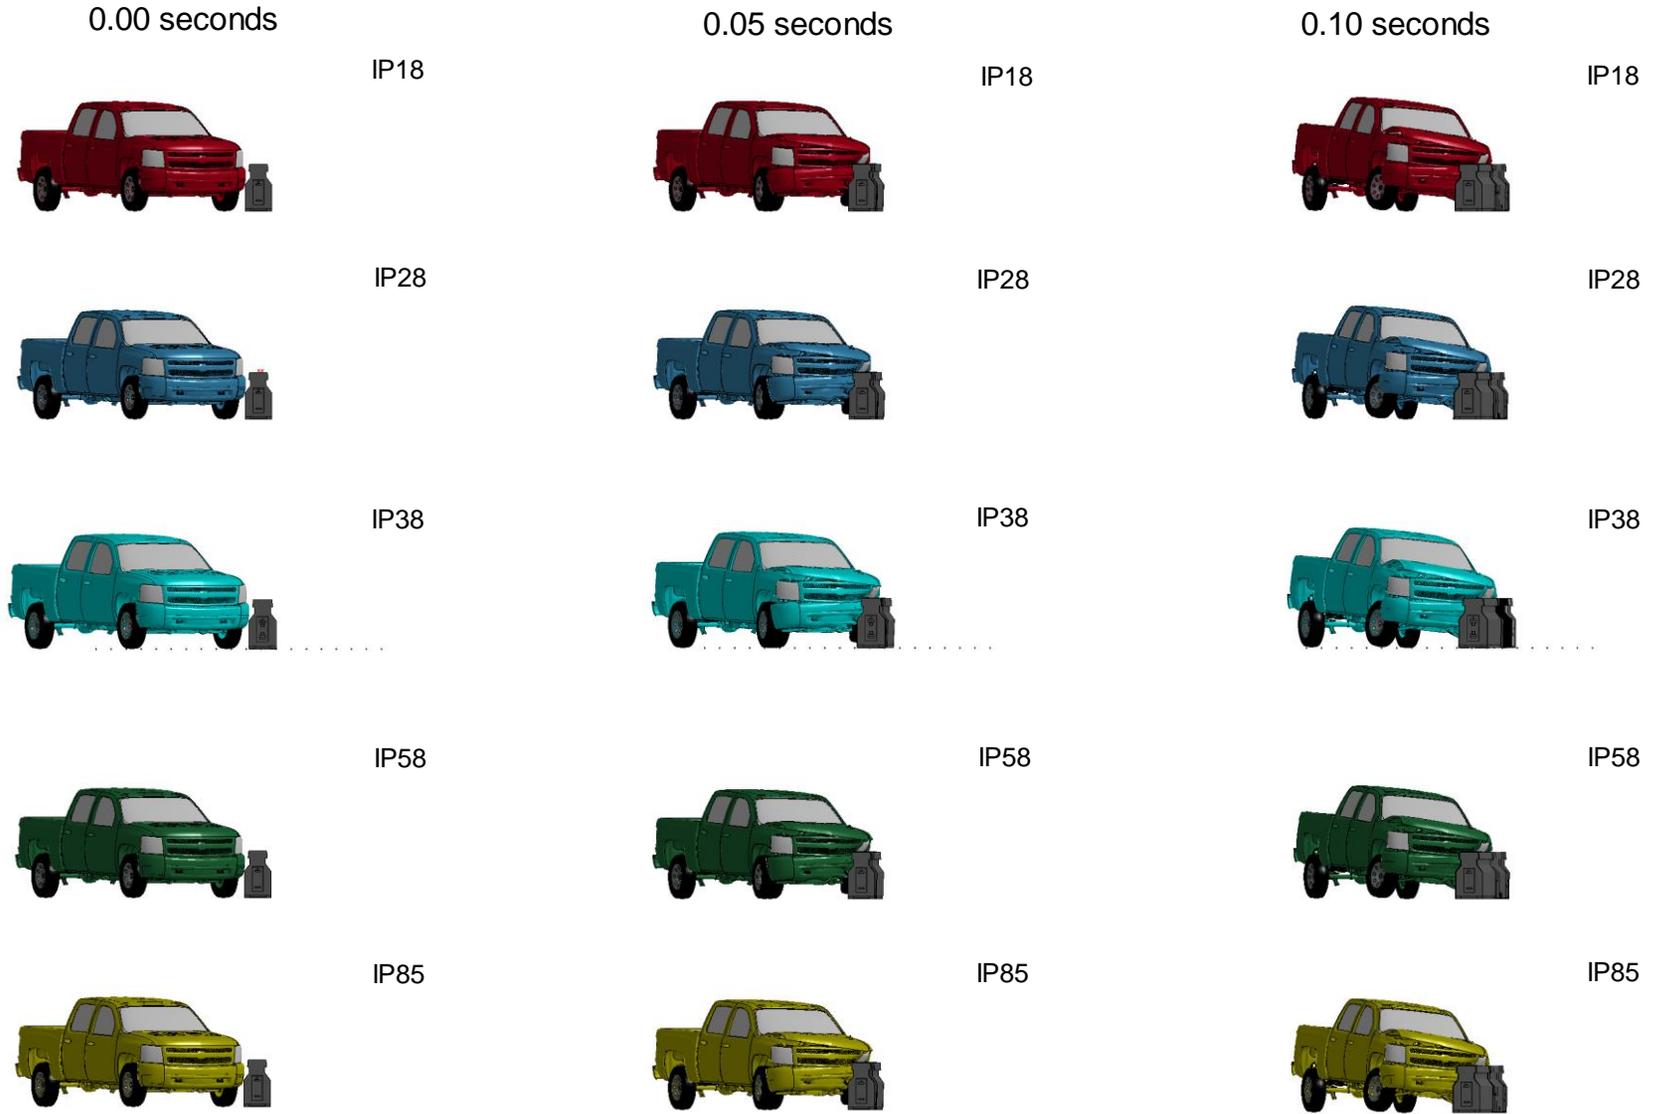
Figure G-2. Sequential views from a downstream viewpoint for IP18 through IP85.

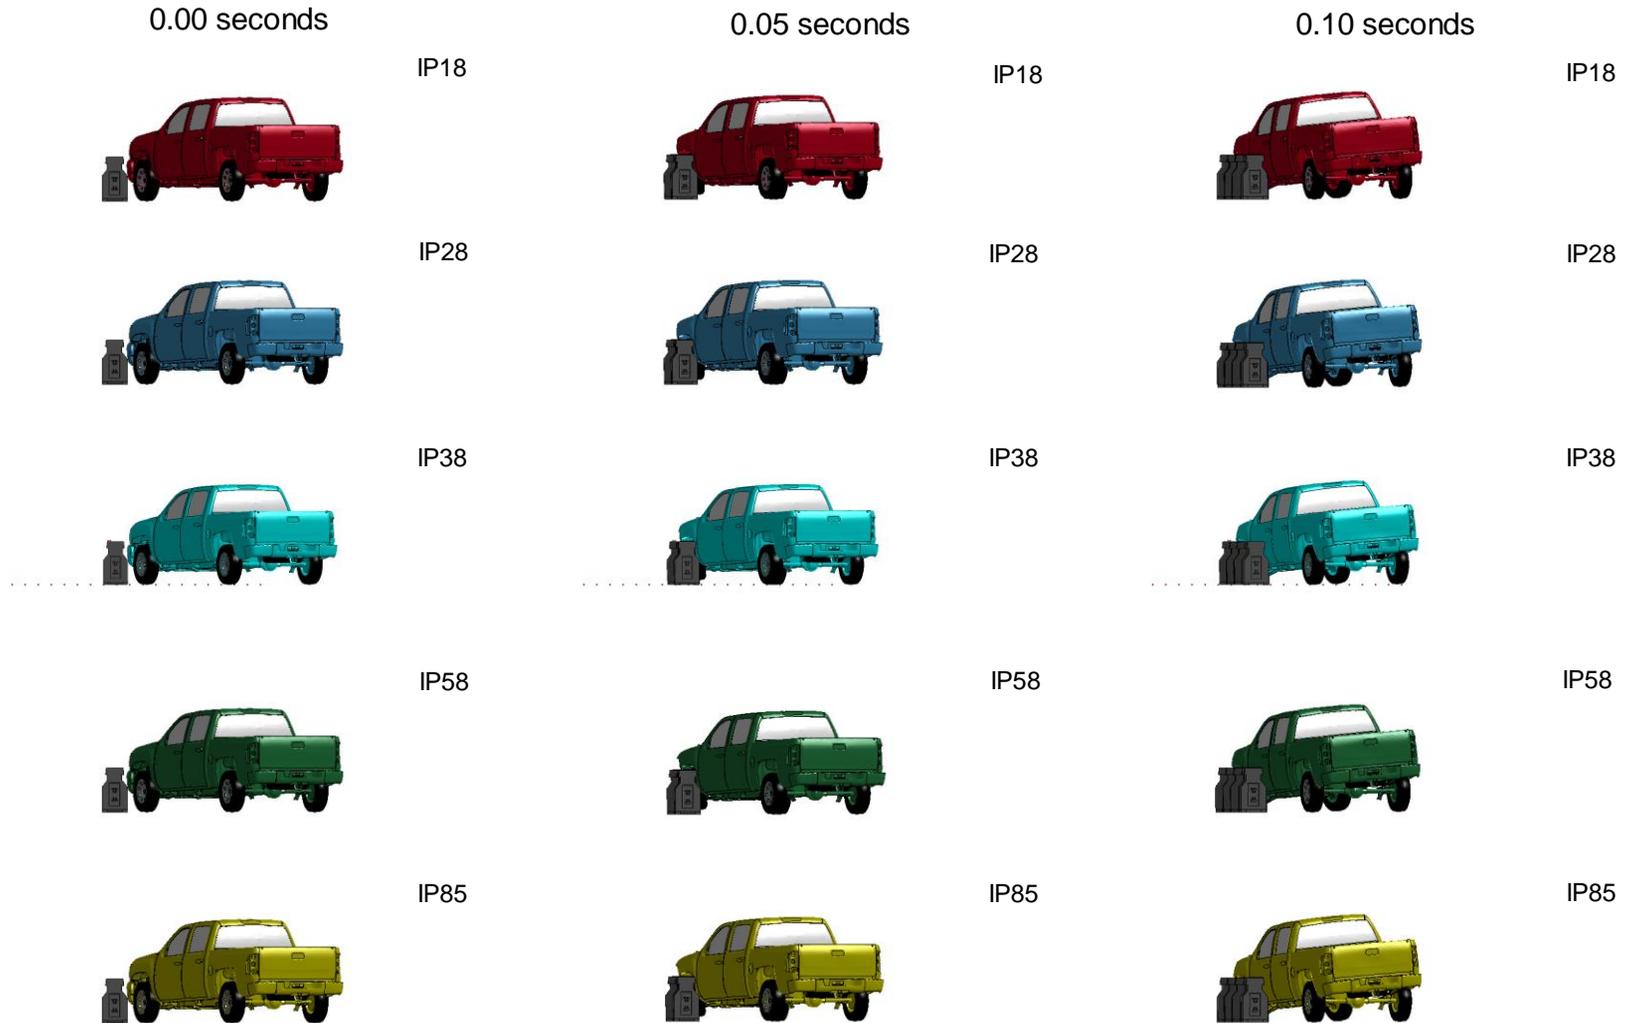
Figure G-3. Sequential views from an upstream viewpoint for IP18 through IP85.

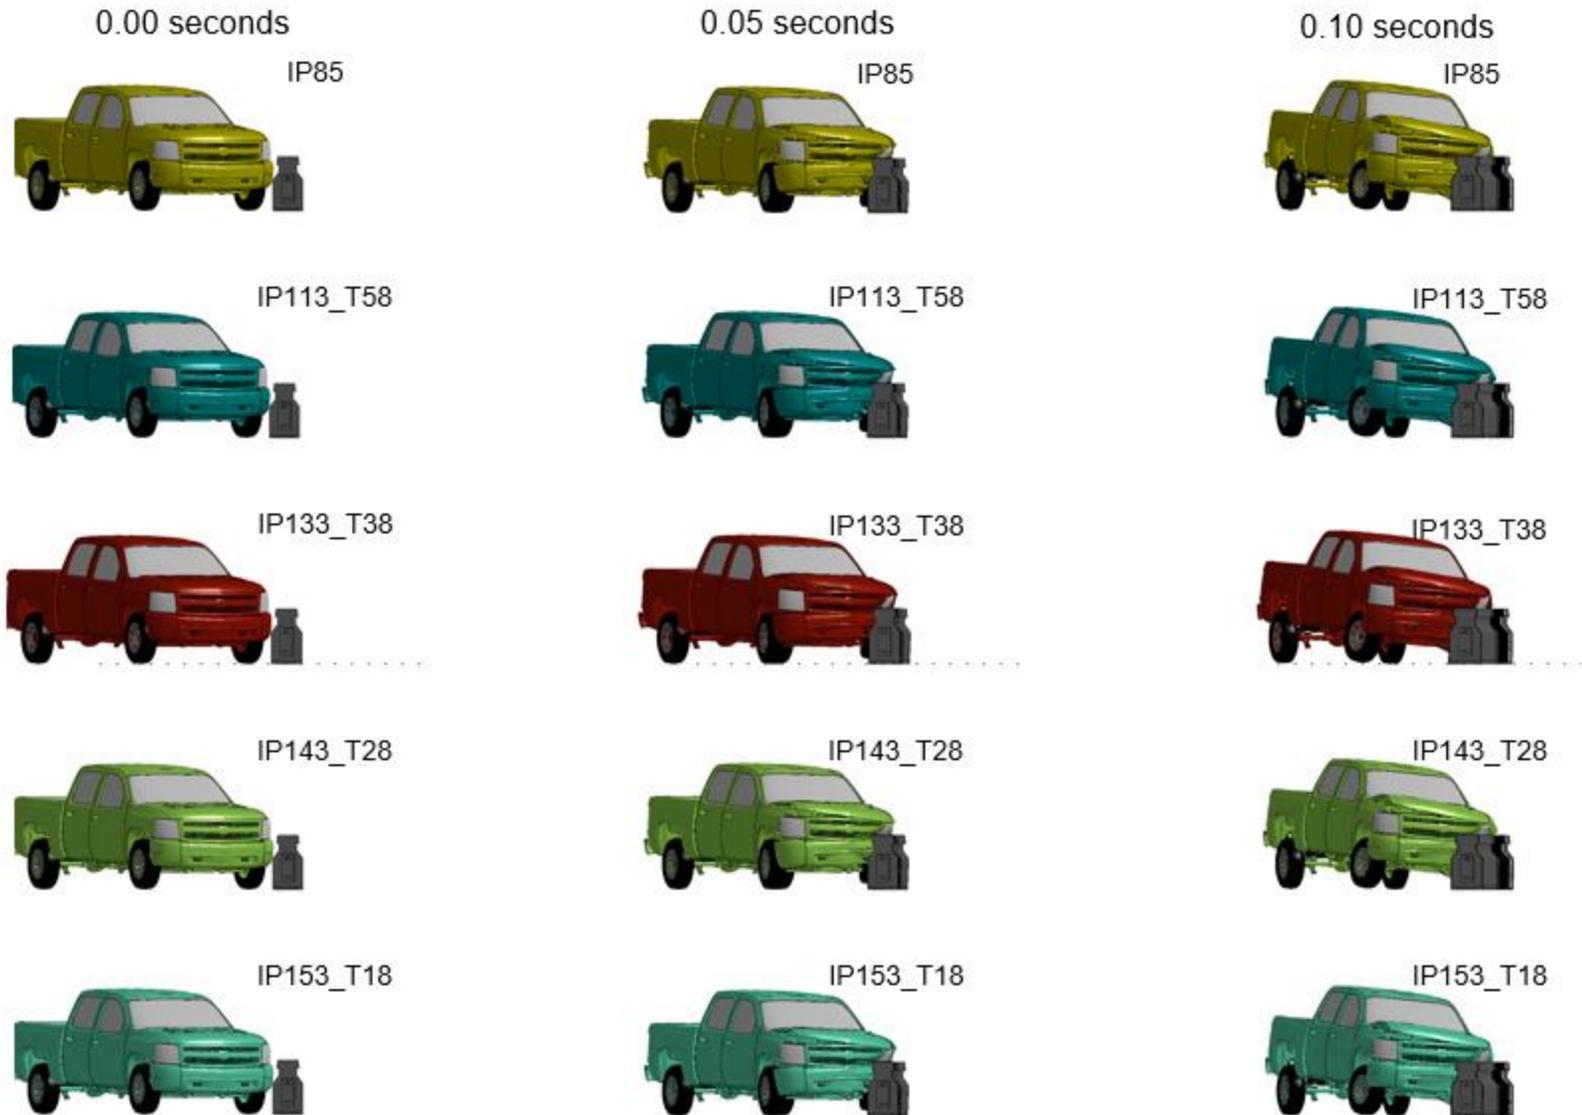
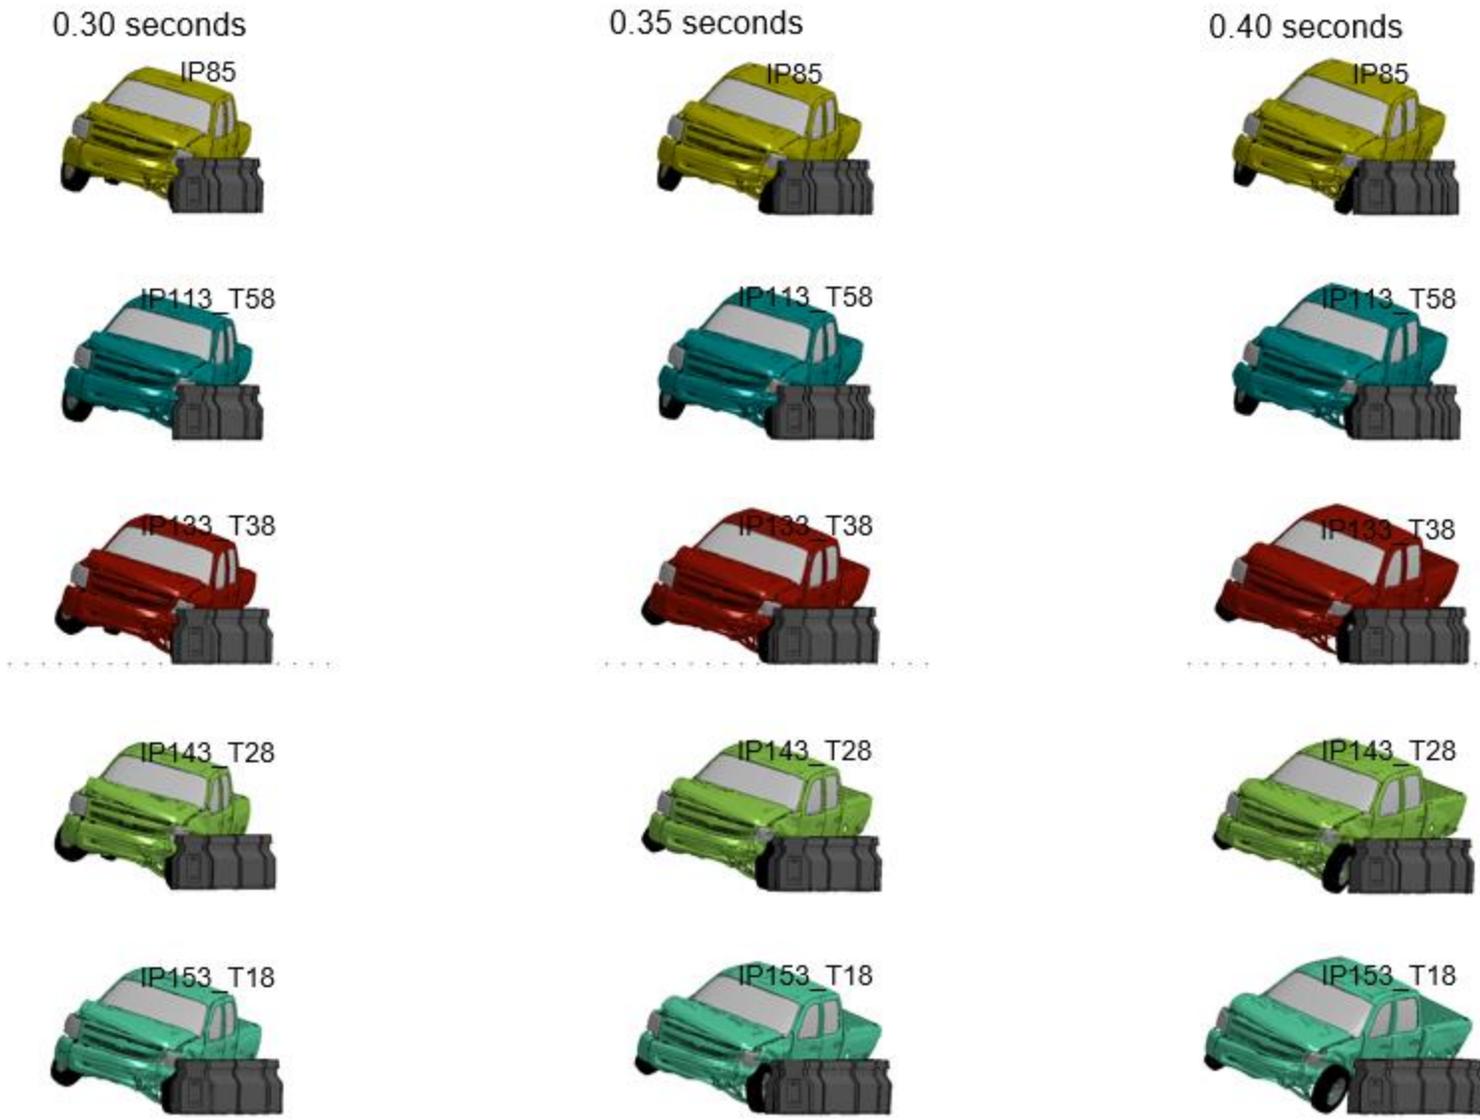
Figure H-2. Sequential views from a downstream viewpoint for IP85 through IP153_T18.
