ATTACHMENT B

NCHRP Project 22-28, FY 2011

Criteria for Restoration of Longitudinal Barriers, Phase II Comments on the June 2014 Quarterly Report

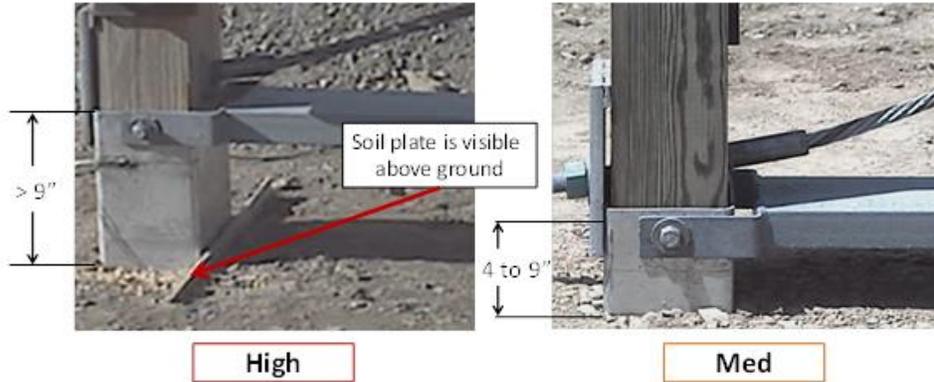
End-Terminal Condition

The current example included in the Field Manual is shown below. We think this is sufficient but will consider other graphical formats for conveying the damage mode.

Foundation Tube:

Stub Height:

$$\text{Stub Height} = \begin{cases} >9'' & \text{High} \\ 4-9'' & \text{Med} \end{cases}$$

Combination Mode:

$$\text{Combination Mode} = \left\{ \begin{array}{l} \text{Hazard within } 50'' \text{ behind rail, and} \\ \text{Stub height } > 7'' \text{ and} \\ \text{Line posts DL1 or worse} \end{array} \right\} \text{High}$$

A stub height exceeding 9 inches corresponds to excessive reduction in anchor strength and is therefore considered high priority for repair. This condition is evident when the soil plate on the foundation tube protrudes more than 1 inch above grade.

Additionally, for wood post guardrail systems such as the G4(2W), when a fixed/rigid hazard is located within 50 inches behind the face of the guardrail, then a stub height greater than 7 inches is considered high priority for repair if the guardrail line posts have deterioration level of DLI or greater.”
