Paper No. 15-2833

Effects of Guardrail Post Deterioration on Crash Performance of Wood Post W-Beam Guardrails

6 Chuck A. Plaxico and Malcolm H. Ray
7

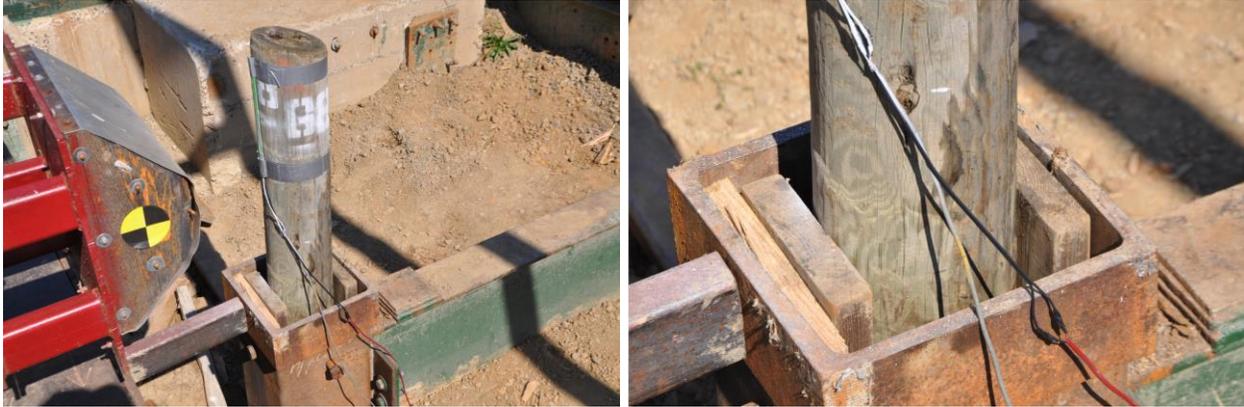
27 The tests were performed with the posts installed in a rigid steel sleeve, as shown in
28 Figure 1. The sleeve was a 12 x 12 x ¼ inch steel tube fabricated from A500 Class B 58,000 psi
29 structural steel. The top of the tube was reinforced with a 5-inch tall 13 x 13 x ½ inch steel tube
30 welded to the main tube sleeve. The foundation sleeve was braced against the steel reinforced
31 concrete wall on the inside of the ground-pit using a 7.4 feet long S20x86 structural steel section.
32 The posts were mounted inside the sleeve at a nominal depth of 38 inches. The posts were held
33 in place inside the sleeve using structural grade 2x8 inch pine boards that were press-fit against
34 the back-side of the sleeve using a 1.0-inch diameter grade 8 set-screw. Additional details
35 regarding the pendulum test program can be found in Plaxico *et. al.*[Plaxico15]
36

Figure 1. Rigid steel sleeve used for post mounting.
