# **Quarterly Progress Report**

**On Project 22-28**

## **CRITERIA FOR RESTORATION OF LONGITUDINAL BARRIERS, PHASE II**

For period  
July 1 – September 31, 2014  
QPR #11

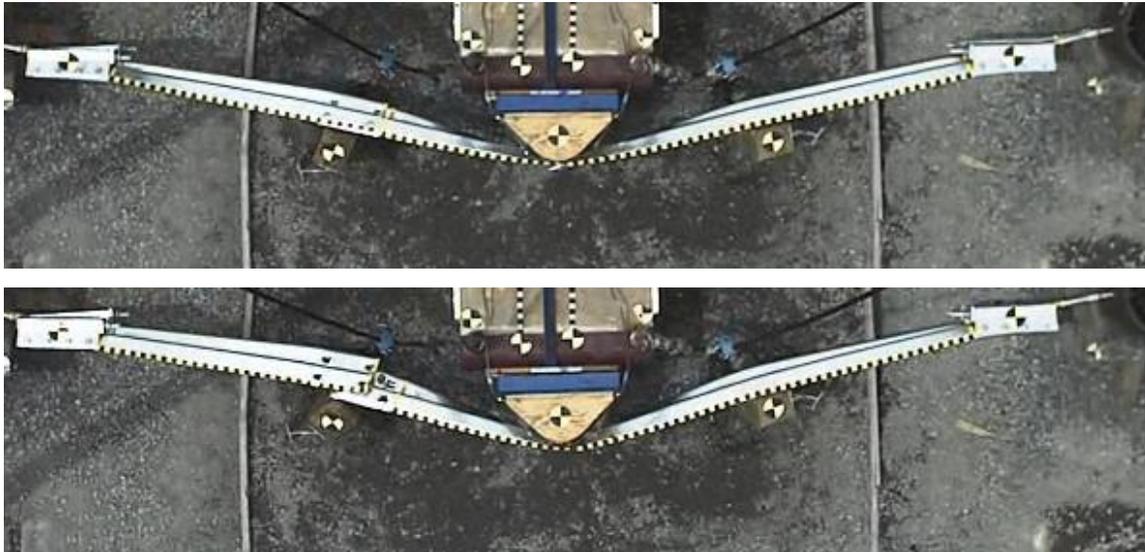
The damaged splice specimens were delivered to the FOIL on 8/11/2014. The original plan was to use the same test setup that Gabler et.al used for testing the damaged splice in Phase I. After critical review of the test video, it was determined that this test setup tended to result in the splice rupturing in pure tension, which is not generally the mode of failure in full-scale tests. Because of the short length of rail and the “rigid” constraint on the boundaries, the rail would develop very high tensile forces at relatively low rail deflections.

Unfortunately, the length of rail could not be extended beyond these limits due to the limited space at the pendulum test site. One alternative would be to design the boundary conditions to mimic the longitudinal and lateral stiffness behavior of an extended guardrail, but such an effort was beyond the scope of this study. It was therefore decided to modify the test setup such that the rail would bend at the post (typical of a normal pocket that develops in a crash event), as illustrated in the figure below. The test setup involved a single W6x16 structural steel post with wood blockout installed downstream of the impact location at the splice connection. There was no post installed upstream of the impact point in order to permit the maximum amount of deflection prior to developing full tension in the rail. The rigid W6x16 post was used to limit the amount of deflection of the post and force the bending mode of the splice around the post. More details of the test setup are documented in the Task Report.

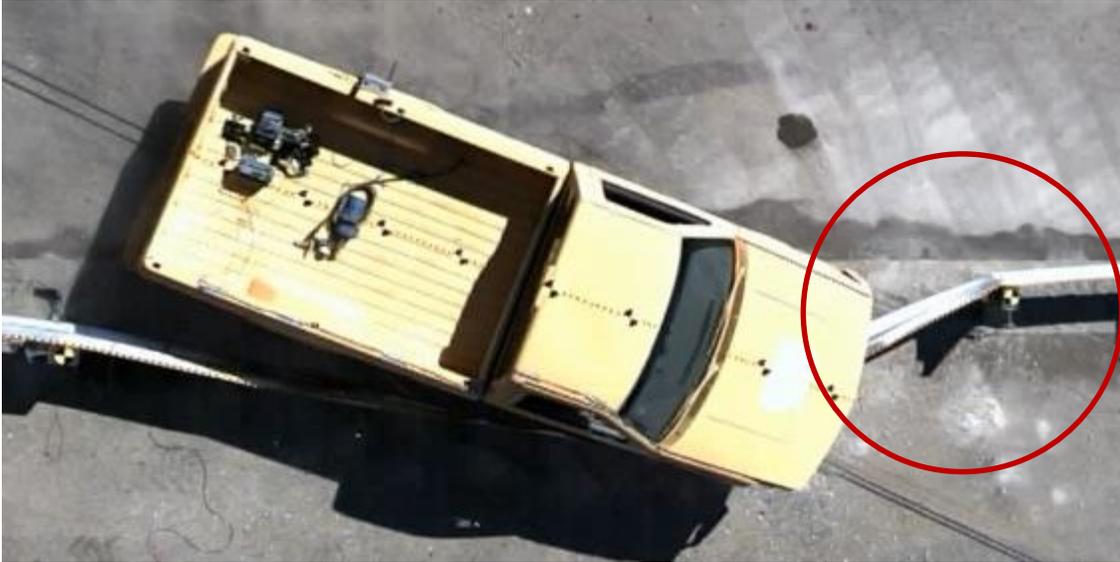
This setup resulted in a somewhat more realistic deformation of the rail at the post prior to rupture of the splice, but the predominate failure mode was still tensile (pull-through of splice bolts).

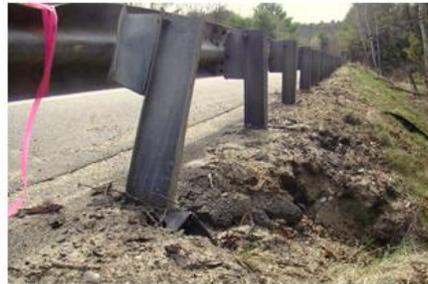
*Erosion at a Single Post within a Four-Post Span:*

$$\text{Erosion} = \begin{cases} \geq 12'' & \text{High} \\ 9 - 12'' & \text{Med} \end{cases}$$

Erosion depth of 12 inches or greater around the post indicates high priority for repair due to increased potential for excessive pocketing and rail rupture.

Erosion depths of 9 to 12 inches were found to compromise system performance, but the guardrail should function adequately under a majority of impacts. This damage level is classified as medium.

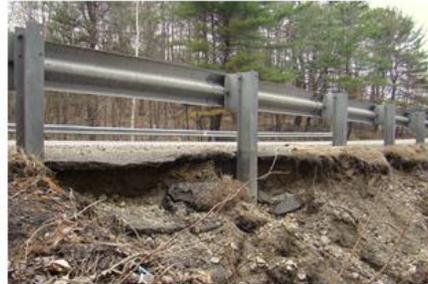
*Erosion at Multiple Posts within a Four-Post Span:*

$$\text{Erosion} = \begin{cases} \geq 6'' & \text{High} \\ 4 - 6'' & \text{Med} \end{cases}$$

Soil erosion depth of 6 inches or greater at two or more posts within a four-post span indicates high priority for repair, due to increased potential for pocketing and rail rupture.

Erosion depth of 4 to 6 inches at two or more posts was found to compromise system performance, but the guardrail should function adequately under a majority of impacts at those erosion levels. The lower bound value of 4 inches was based on engineering judgment, since the study did not include erosion depths less than 6 inches. The upper bound value of 6-inches erosion was based on high magnitude strains around the splice-bolt holes in the w-beam, which were considered borderline regarding high potential for rail rupture.
